California Division of Mines and Geology

Fault Evaluation Report FER-90

May 16, 1979

Dixieland fault.

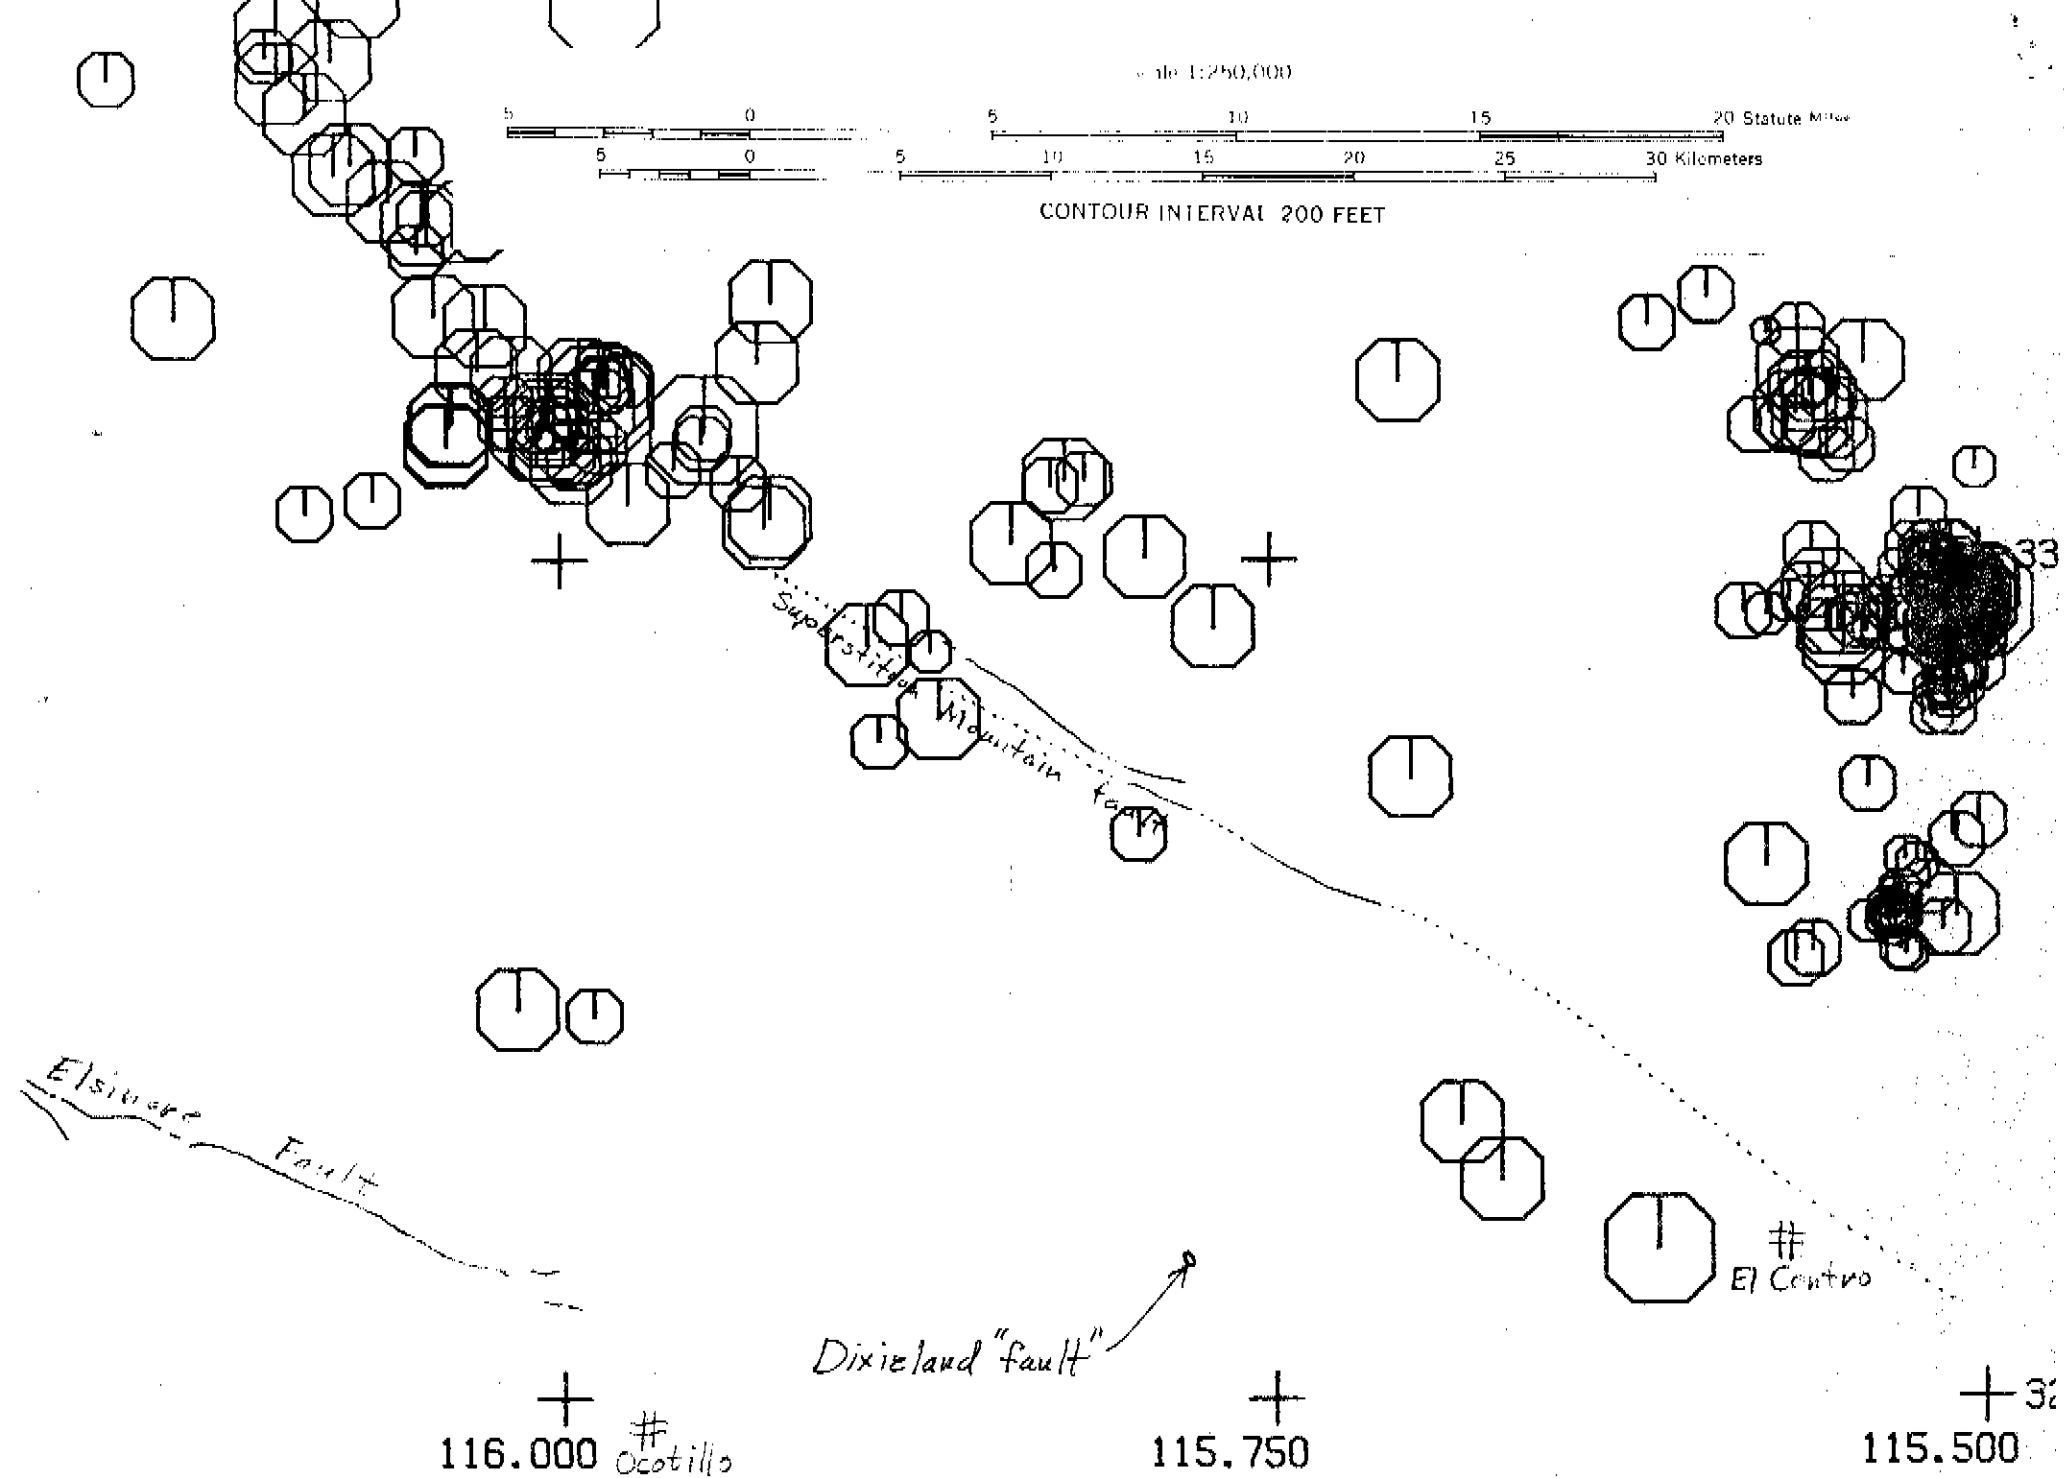
The epicenter map (figure 2) shows no epicenters closer than 10 km to the Dixieland fault.

Figure 2. Seismicity in the regional vicinity of the Dixieland fault.
"A" quality epicentral plots from Real and others (1977).
